**DOT/FAA/AR-09/4**

# **Effects of Disbonds, Lightning Strikes, and Low-Velocity Impact Damage on Adhesively Bonded Composite Joints**

December 2009

Final Report

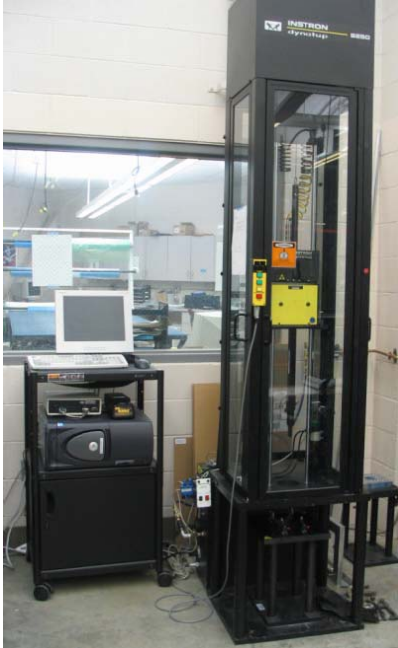
Figure 9. Instron Dynatup Drop-Weight Tester

PFS test specimens were impacted using a gravity-assisted drop tower (figure 8), while SLS specimens are impacted using an Instron Dynatup<sup>®</sup> 8250 drop-weight impact tester (figure 9). Impact force was measured using a piezoelectric load cell attached to the impact mass assembly. Both impactors were equipped with a pneumatic rebound catch mechanism that prevented secondary impacts on the test specimens and a photodetector or flag system that provided impact velocity information. Data acquisition software, which runs on a computer connected to each drop-weight impact tester, collected and reduced the impact test data. A sensor (flag), which was placed closer to the impact location, triggered the data acquisition system a few milliseconds prior to the impact event. This sensor and another flag placed a known distance adjacent to that were used for impact velocity calculation ( $\text{velocity} = \text{distance}/\text{time}$ ).

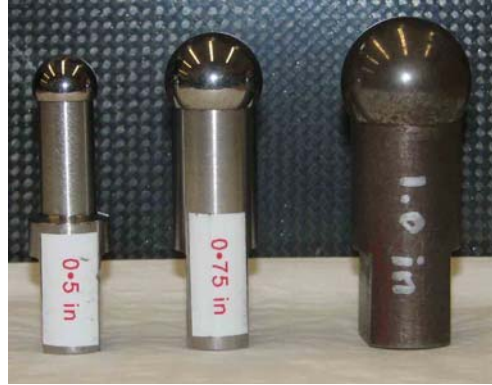
Figure 11. Impactors Used for SLS Specimens

Prior to impact, specimens were placed in the support fixtures, as shown in figure 10, and held rigidly. These fixtures had dowel pins for aligning the specimens. Impactors used for the SLS specimens are shown in figure 11. SLS specimens were impacted with 0.50-, 0.75-, and 1.00-inch impactors, and PFS specimens were impacted with 0.25-, 0.50-, 0.75-, 1.00-, and 2.00-inch impactors. Several PFS specimens were impacted using a support fixture that had an 8 by 8-inch opening (unsupported region), and the remainder were impacted using a support fixture that had a 4.5- by 4.5-inch unsupported region. These two fixtures are referred to as large (L) and small (S) support fixtures throughout this report. All SLS specimens were impacted with a support fixture that had a 3-by 4-inch unsupported region.

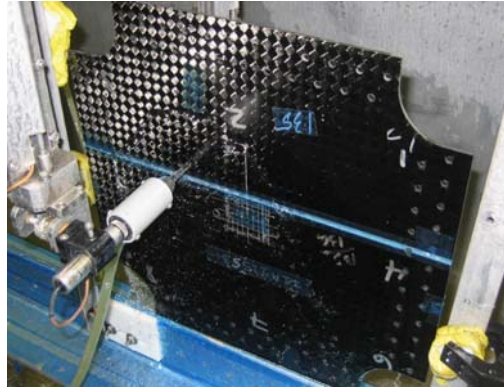
Figure 13. A TTU Scan of a PFS Test Specimen

The impacted specimens were subjected to through-transmission ultrasonic (TTU) NDI that generate C-scans to quantify the damaged planar areas using image-analysis software (figure 13). A TTU C-scan provided a projection of damage that was incurred on both adherends, the adhesive layer, and the adhesive/adherend interfaces. Therefore, care was exercised when interpreting the failure mechanism. Additional inspections, such as microscopy, x-ray, and thermal imaging, may be required to quantify the damage on adhesive, adherends, and interfaces.

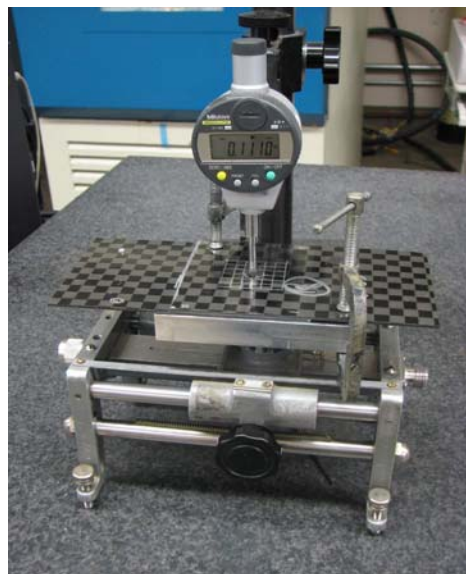
Figure 14. Setup for Residual Indentation Depth Measurement

Once impacted, the residual indentations of these specimens were measured using a digital gage that was attached to a traverse (figure 14). With the center at the impact point, the postimpact surface contour was measured over an area of 1.5 by 1.5 inches. As shown in figure 15, the depth measurements relative to undamaged surface were measured and plotted, using the Golden Software Surfer® computer program, to visualize the surface indentation. The data, enhanced for easy visualization, is not shown to scale.

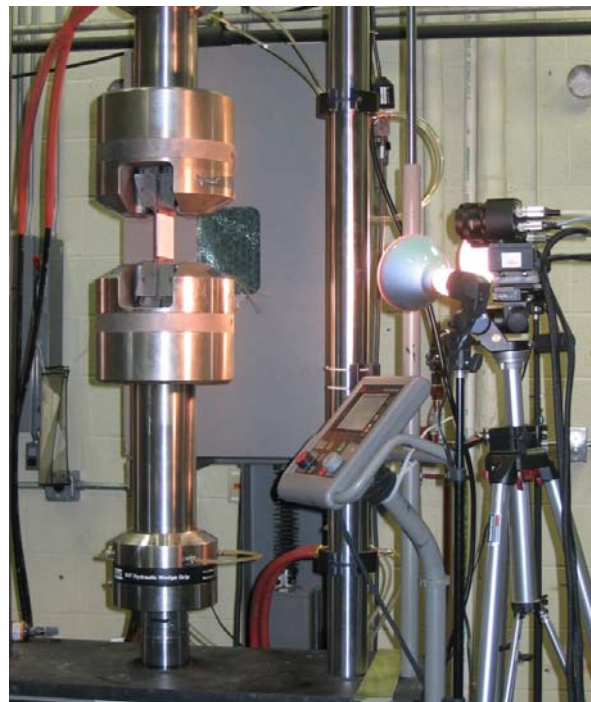
Figure 16. The MTS Servo-Hydraulic Test Frame

PFS and SLS residual strength tests were conducted using 110- and 55-kip MTS servo-hydraulic test frames, respectively. The picture-frame test fixture was mounted to clevis attachments of the test frame, as shown in figure 4. SLS specimens were mounted to the test frame using a hydraulic grip assembly, as shown in figure 16. The grip assembly was equipped with 4-inch-wide wedges and provided with a uniform pressure of 3000 pounds per square inch (psi). While gripping the specimens, the actuator was programmed in load-control mode to prevent unnecessary preloading due to grip pressure. Both PFS and SLS tests were conducted in displacement-control mode with a rate of 0.05 in/min, while acquiring data at a rate of 10 Hz.

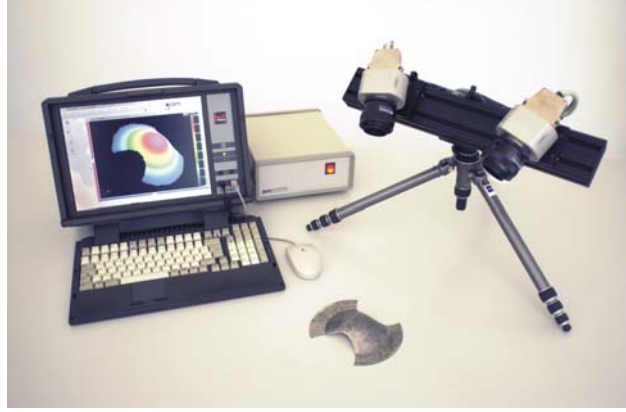
Figure 19. Portable Version of ARAMIS Photogrammetry System [4]

The ARAMIS photogrammetry full-field strain measurement system was used to measure localized buckling in the region of disbonds and defects (see figure 19). ARAMIS [4] is a noncontact, optical, three-dimensional deformation-measuring system. It uses two high-definition cameras to track translation and rotation of the surface details (object characteristics) with subpixel accuracy. Surface details are obtained by applying a stochastic color pattern that follows surface displacement during loading. ARAMIS uses this pattern to recognize the surface structure and uses digitized images through both cameras for triangulation of surface details (micropattern) to determine precise location of each point. Therefore, this system has the capability of digitizing the precise shape (surface) of the structure during loading. The first set of coordinates for object characteristics are obtained in the undeformed stage. After load application, a new set of coordinates (digital images) are recorded. Then, ARAMIS compares the digital images and calculates the displacement and deformation of the object characteristics. ARAMIS is capable of three-dimensional deformation measurements under static and dynamic load to analyze deformations and the strain of real components. In addition, this system is able to eliminate the rigid body motion component from the displacement results. Therefore, it can be used for specimens that exhibit large displacements. Strain sensitivity of the system is approximately 100-200 microstrains, and the scan area can be as large as 47 by 47 inches.

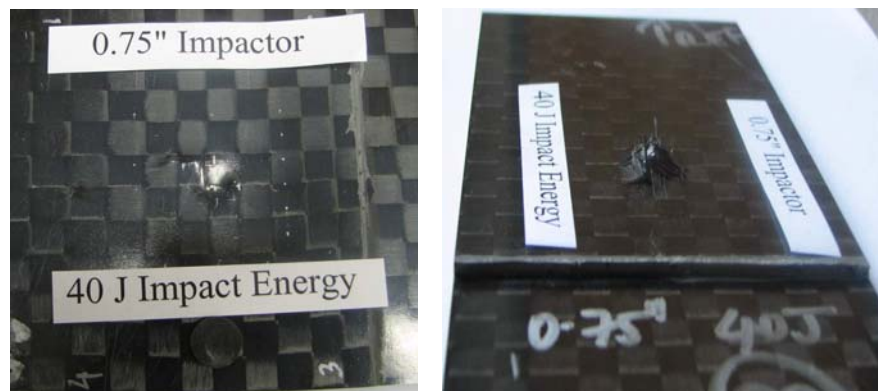
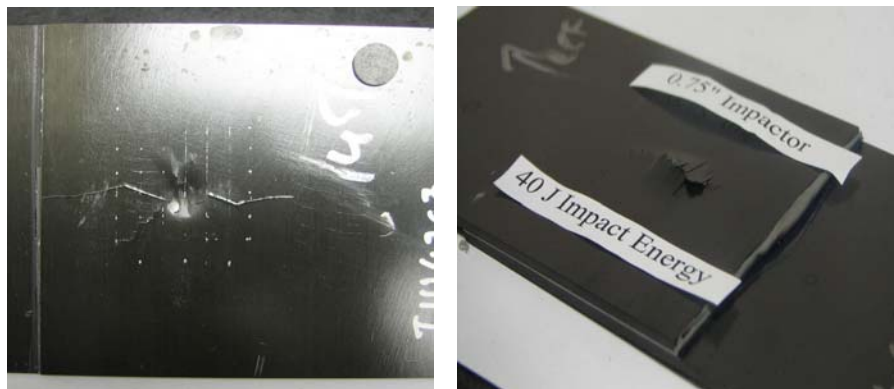
Figure 45. Impact Damage Induced on FGSW With 0.5-Inch Impactor

Figure 46. Impact Damage Induced on FGSW With 0.75-Inch Impactor

Figure 47. Impact Damage Induced on FGSW With 1.00-Inch Impactor

Figure 48. Impact Damage Induced on CFPW With 0.5-Inch Impactor

Figure 49. Impact Damage Induced on CFPW With 0.75-Inch Impactor

Figure 50. Impact Damage Induced on CFPW With 1.00-Inch Impactor

Figure 51. Impact Damage Induced on CFUT With 0.5-Inch Impactor

Figure 52. Impact Damage Induced on CFUT With 0.75-Inch Impactor

Figure 53. Impact Damage Induced on CFUT With 1.00-Inch Impactor

Figures 45 through 53 show the damage induced on the impact side (left) and back sides (right) of FGSW, CFPW, and CFUT SLS specimens for impact energy of 354 in-lbf (40 J) using impactors with diameters of 0.5, 0.75, and 1.0 inch, respectively. Due to the translucent nature of glass fibers, the damage on FGSW specimens can be seen with the naked eye.

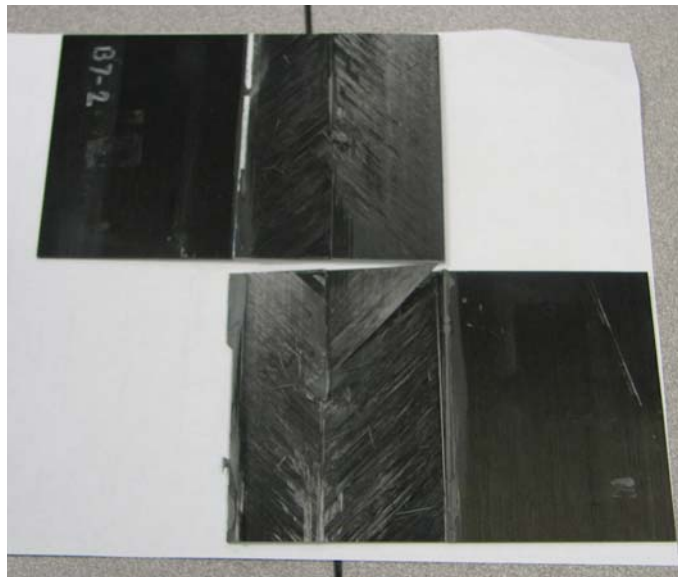
Figure 63. Typical Failure Mode Observed for FGSW SLS Specimens

Figure 64. Typical Failure Mode Observed for CFPW SLS Specimens

Figure 65. Typical Failure Mode Observed for CFUT SLS Specimens

Figures 63 through 65 show typical failure modes observed for FGSW, CFPW, and CFUT SLS specimens. The primary failure mode for all residual strength tests on lap joints was adherend failure (mostly first ply).
